GRASSY TRAIL DAM AND RESERVOIR

MINING-INDUCED SEISMICITY

Summary Report, January 2008

MINING-INDUCED SEISMICITY
NEAR GRASSY TRAIL DAM AND RESERVOIR
Carbon County, Utah

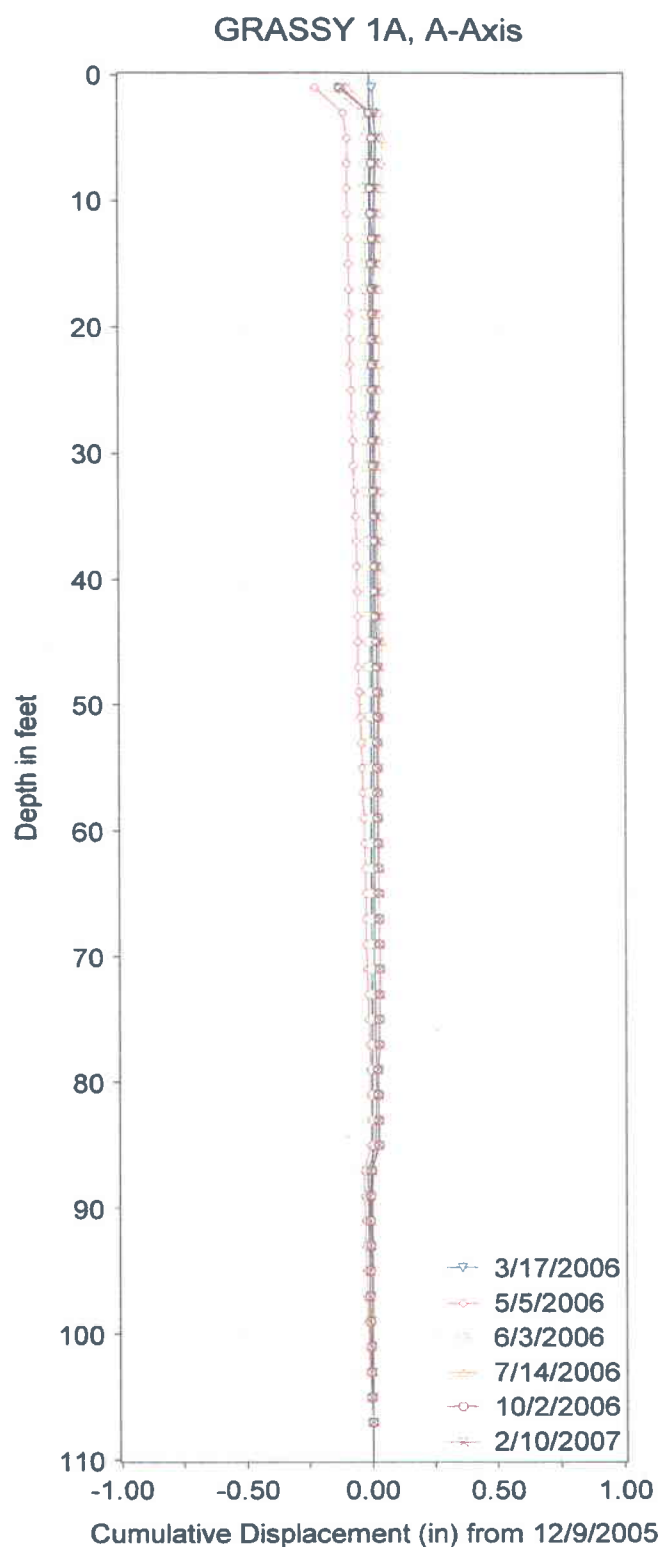
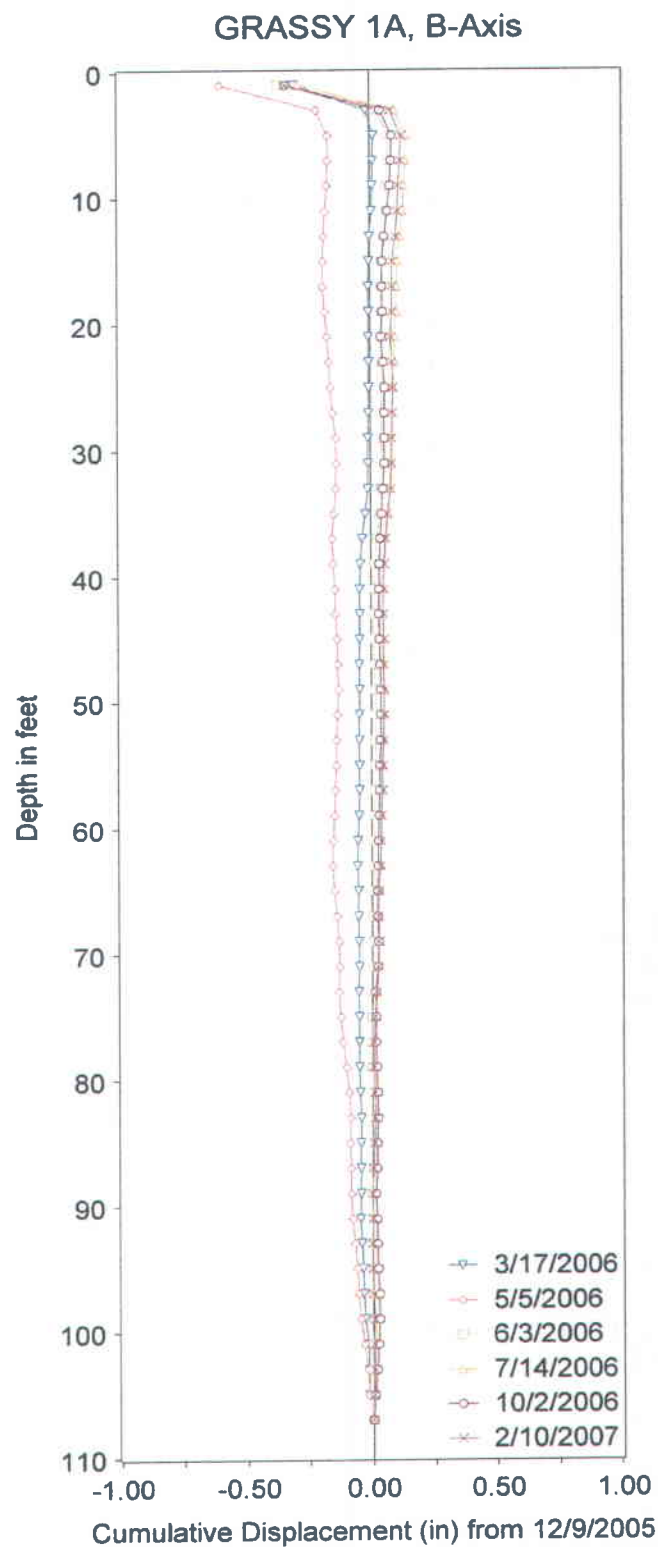
FIGURE B-1

foundation to a total depth of about 107 feet. The positive "A" axis of this inclinometer pipe is oriented into the abutment toward the southeast, and the positive "B" axis is oriented downstream to the southwest. Deflection profiles recorded by Inclinometer 1 are shown on Figure B-1. This figure shows that the uppermost 2-foot deflection interval shows substantially greater deflections than the rest of the readings. This observation indicates only that the pipe is not rigidly confined in the soil in the upper few feet, and is not an indicator of significant ground movements.

With the exception of the uppermost point, the deflections recorded along either Inclinometer 1 axis is less than about 0.2 inch. The maximum deflection was measured on July 14, 2006 and was observed to be in a northerly direction, which is contrary to most of the previous readings showing slight deflections tending to the southwest. A later measurement recorded in October 2006 showed a profile similar to those recorded prior to July 14. The October profile, along with profiles from earlier measurements, suggests that the July 14 profile is likely in error. The magnitudes of the Inclinometer 1 displacements are small, and do not exhibit a significant tendency toward instability in this area.

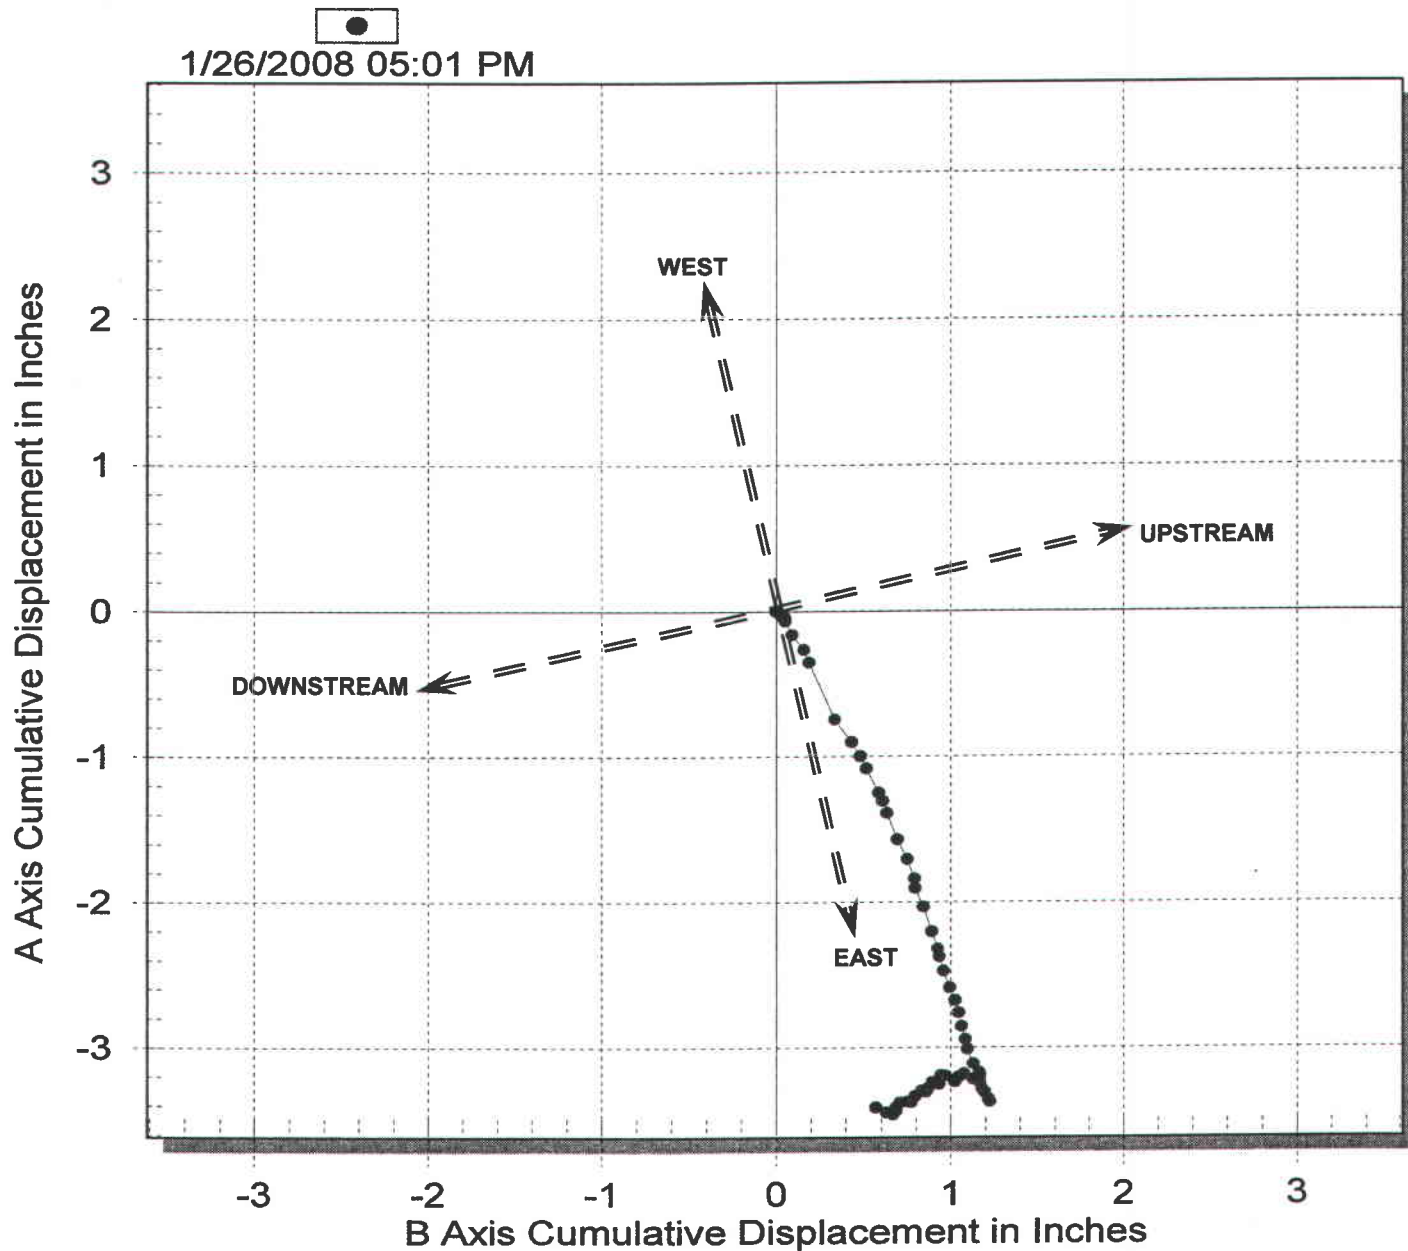
INCLINOMETER 2 - PLAN VIEW OF DEFLECTIONS
GRASSY TRAIL DAM AND RESERVOIR - CARBON COUNTY, UTAH

The deflected shape of Inclinator 2 on October 28, 2006 relative to a baseline shape measured on July 20, 2004 is shown in plan view on Figure B-3. The figure shows that the measured deflections are oriented primarily along the dam axis from the west (right) abutment toward the maximum section to the east. The slight “bulging” noted on the “B” axis profile is in the upstream direction.

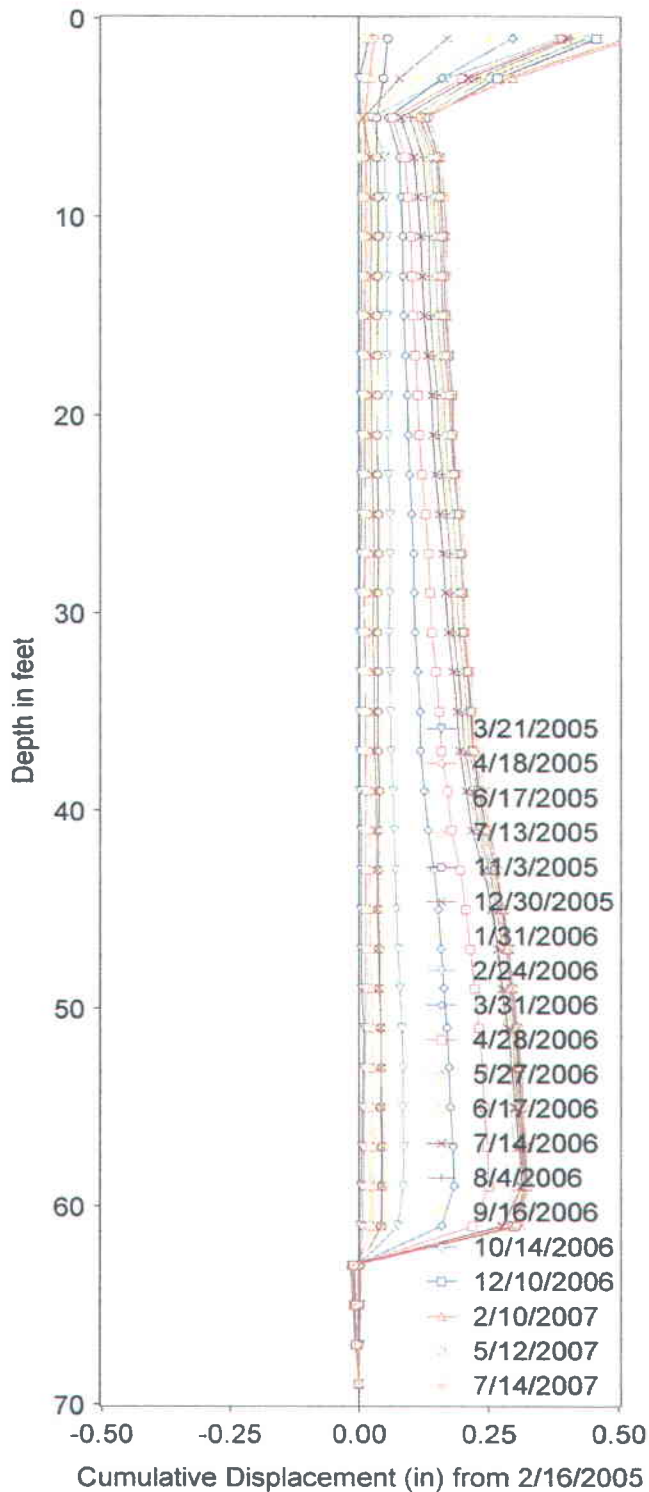
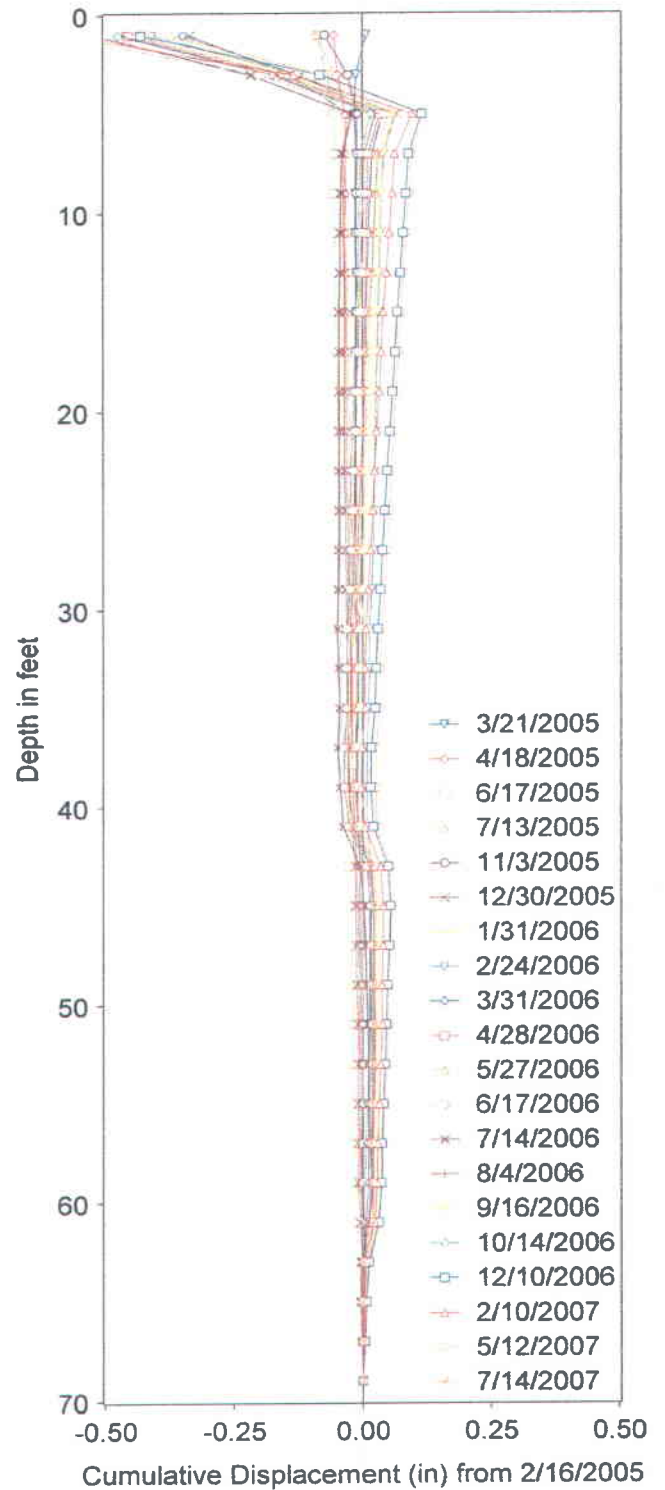
Deflection profiles for Inclinometer 4 are shown on Figure B-8. The profile for the "A" axis exhibits a distinct down-slope displacement between the depths of 61 and 63 feet. Over time, the magnitude of this displacement has increased to approximately 0.3 inch. The maximum displacement is located at a depth of 59 to 60 feet, and the lateral displacement tends to decrease gradually coming up the pipe from that depth. This deflected shape suggests a discrete failure surface at a depth of about 62 feet, with a slight backwards rotation of the moving mass. The larger displacements shown in the upper 3 feet indicate that the top of the pipe is somewhat loose or influenced by shallow ground movement at the edge of the roadway.

The boring log recorded during installation of Inclinometer 4 shows that the bedrock above a depth of 64 feet is primarily mudstone. The log notes that clay seams were present in the mudstone core sample retrieved from a depth of about 61 to 64 feet. The log also shows sandstone below a depth of about 64 feet. Based on the boring log and the observed deflections, it appears that the slip surface is located within the mudstone layer with clay seams encountered immediately above the sandstone.

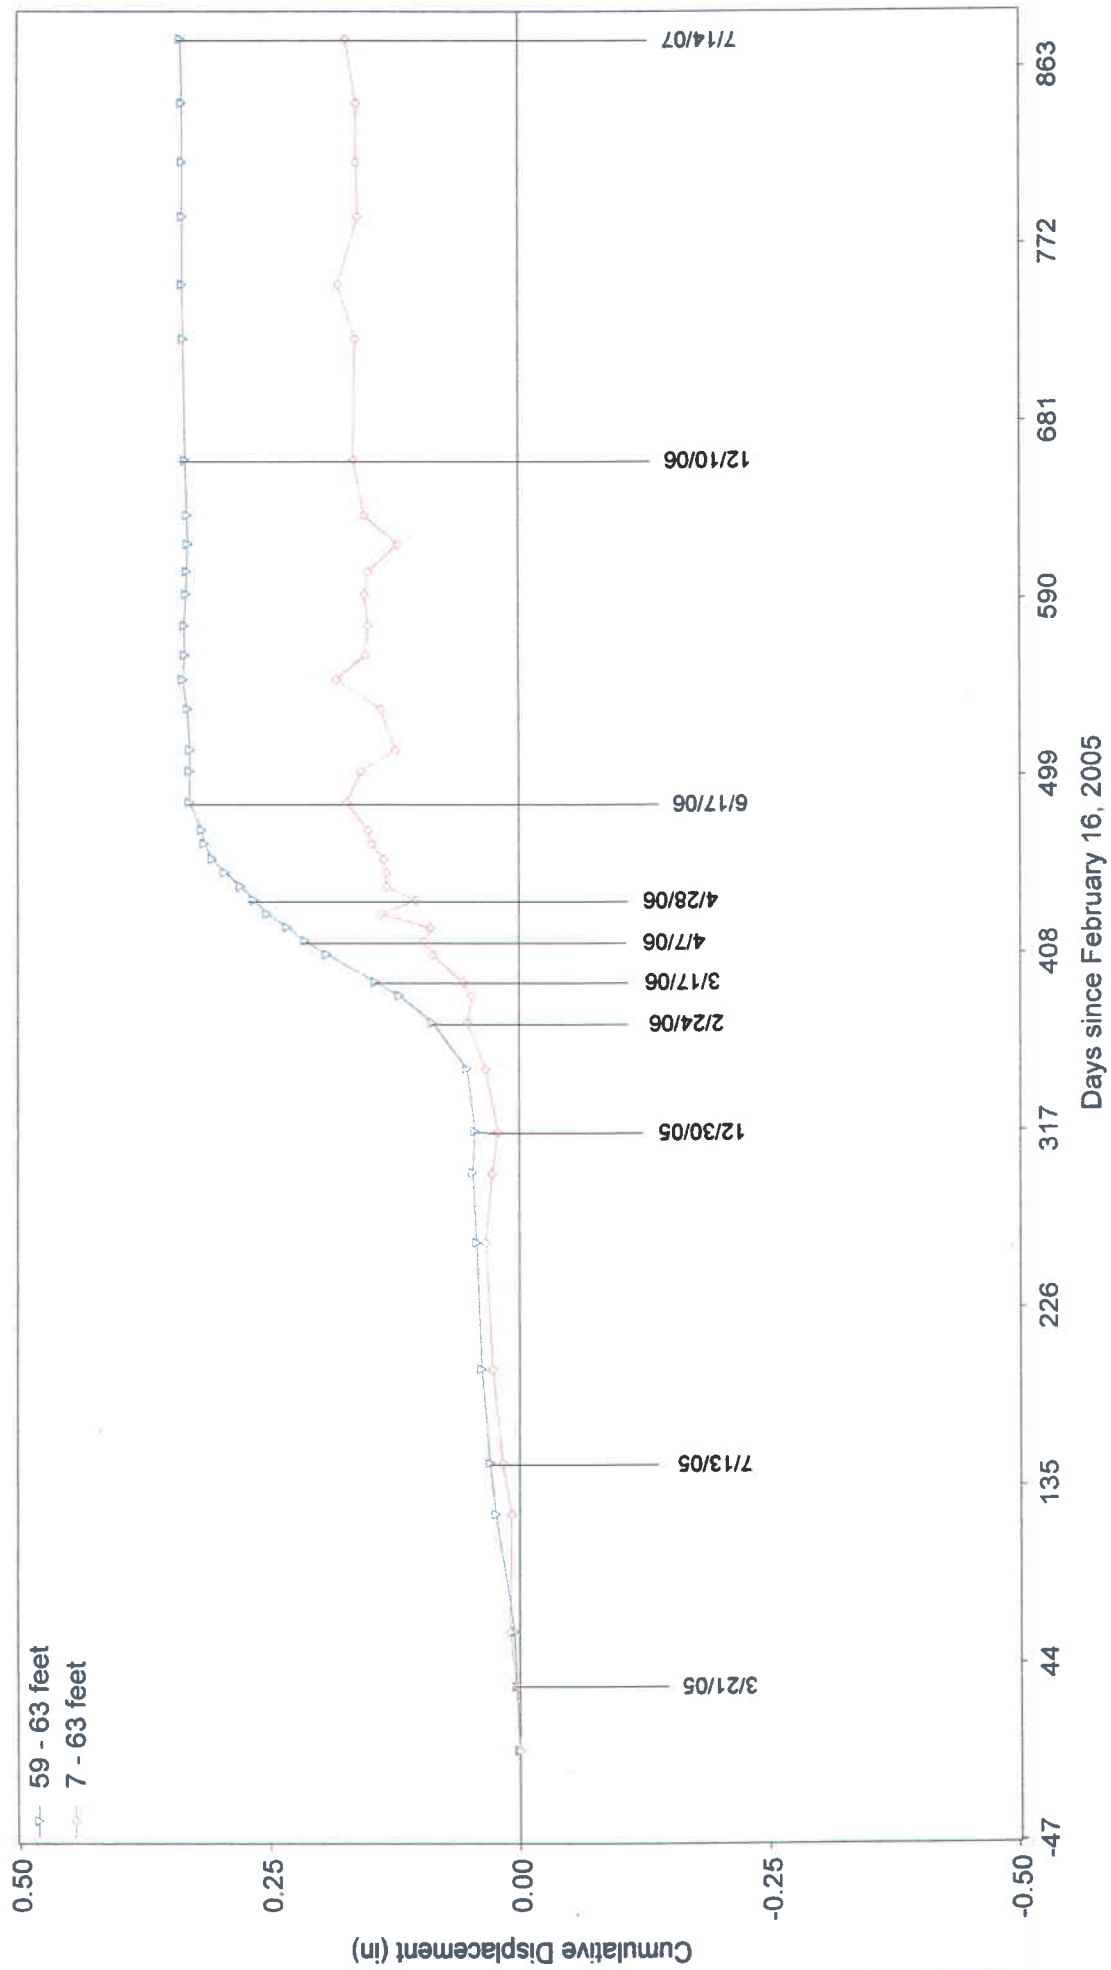
FIGURE B-10
INCLINOMETER 4 - DEFLECTIONS VERSUS TIME
 GRASSY TRAIL DAM - CARBON COUNTY, UTAH

The deflection of Inclinator 4 along the "A" axis is plotted versus time on Figure B-10. The same trend observed at Inclinator 2 and 3 is also apparent at Inclinator 4. One notable difference is that the deflections attributable to mining of Panel 7 appear to subside several months earlier (around June 2006) at Inclinator 4, while they continue until about August in the west abutment area of the dam. The approximate zones of mining during which the most significant deflections occurred at Inclinator 2, 3, and 4 are shown on Figure B-11. This different influence zone for Inclinator 4 suggests that the slide mass monitored by Inclinator 4 may be less sensitive than the west abutment area to smaller ground motions originating at a greater distance. Another possible explanation is that the displacements measured prior to June 2006 may have moved the slide mass into a more stable position, thereby increasing the threshold level for ground motions to cause significant displacements.

The inclinometers suggest that slight deformations (creep) may be ongoing at the dam's west abutment. Continued monitoring of these inclinometers is recommended to verify that the rate of this movement does not increase. Regular monitoring of piezometers and seepage collection points is also recommended to verify that the recorded lateral movements do not result in increased seepage and/or internal erosion of the dam. This monitoring is critical to ensure adequate long-term performance of the dam and the safety of people and facilities located downstream.

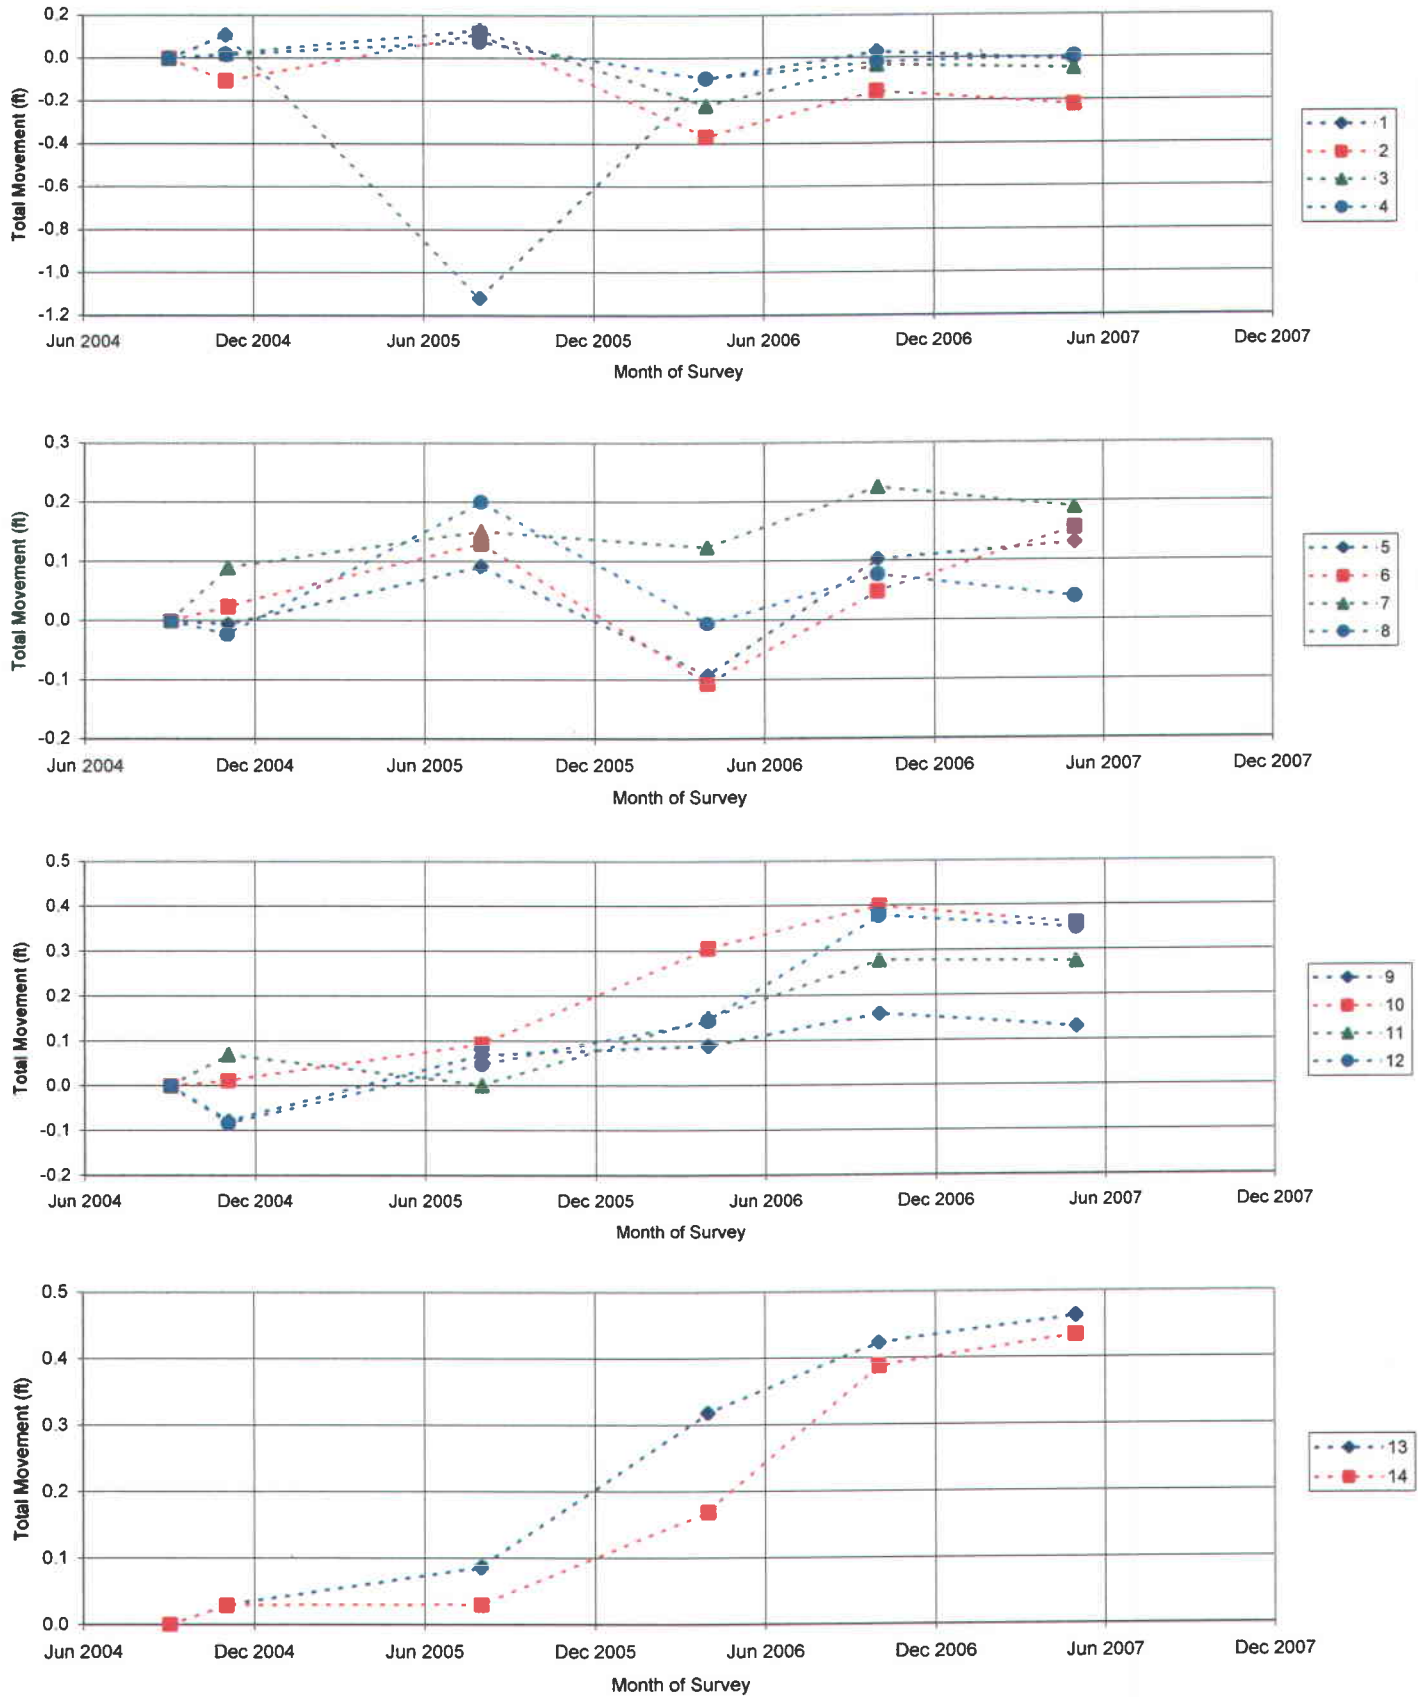
FIGURE D-2a

The changes in the surveyed northing, easting and elevation coordinates for points 1 through 14 are plotted on Figures D-2a, D-2b, and D-2c, respectively. It will be noted from Figure D-2a that the uppermost points (Points 1 through 8) do not exhibit a clear trend of displacement in any particular direction. Point 1 shows a northerly displacement greater than one foot in the August 2005 survey, but returns to very near its original position in the following survey. The displacement of Point 1 shown in August 2005 is likely an error in the survey or in data tabulation.

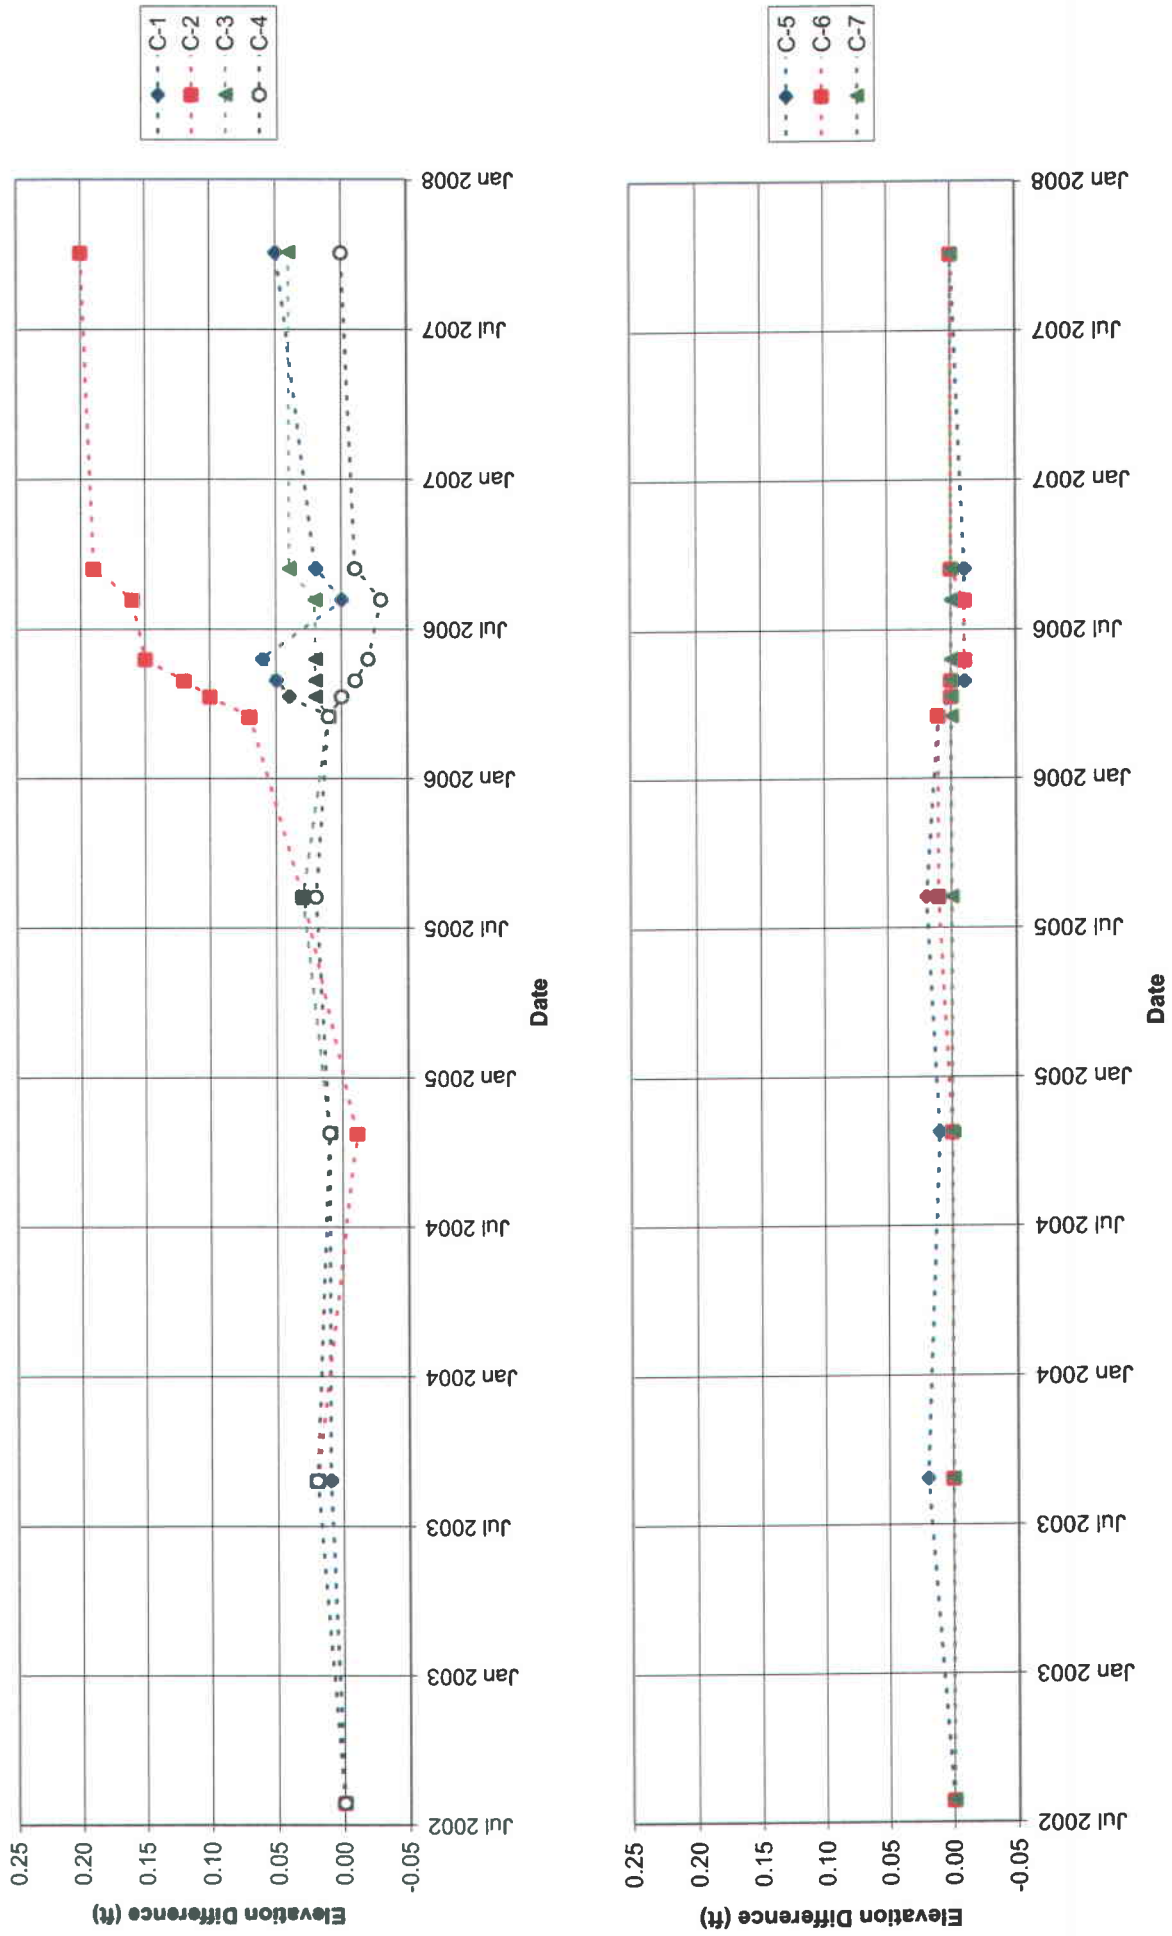
The surveyed elevations of the monuments on the dam crest are tabulated on Table D-3 in Appendix D, and the differences in elevation using the July 2002 survey as a baseline are plotted on Figure D-5. This figure shows that most of the elevation differences were less than 0.05 foot. The points located on the westerly half of the dam (C-1, C-2, C-3, and C-4) nearest the mining activities appear to have undergone some vertical displacement. Slight upward displacements are evident during mining of Panel 6 in 2005, with more significant displacements noted during mining of Panel 7 in 2006. The points on the easterly half of the dam (C-5, C-6, and C-7) appear to have undergone very little vertical displacement during the survey period.

Settlement monument C-2, near the west end of the dam, showed slight signs of upward movement during Panel 6 mining, followed by more significant upward movement during mining of Panel 7. The monument elevation has increased about 2.4 inches. This observation, along with the observed lateral movement of 3.5 inches, suggest that movement in the west abutment area has pushed the west abutment several inches upward and toward the east.
